2019 Flood Response & Recovery
Iowa DOT / FHWA / ACEC Transportation Conference
September 11, 2019
M.J. "Charlie" Purcell, Project Delivery Division Director

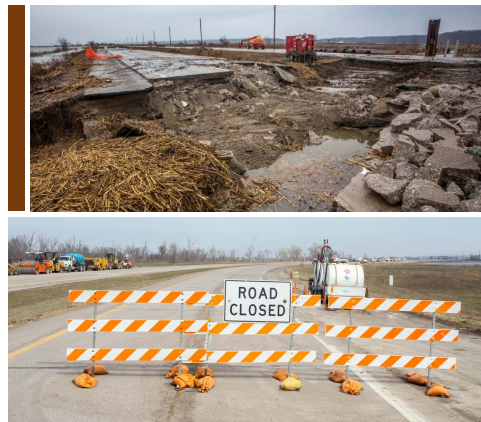
Interstate 29
North of I-680

- 0.2 Mile Severe Roadway Damage
- 2.4 Miles Severe Shoulder Damage
- 1.4 Miles Minor Shoulder Damage
- 1** Culvert Damage

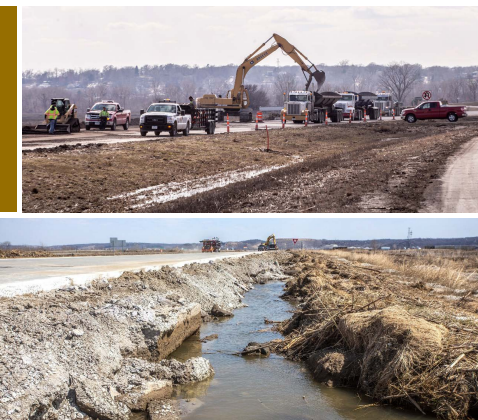
Interstate 680

- 1.5 Miles Severe Shoulder Damage

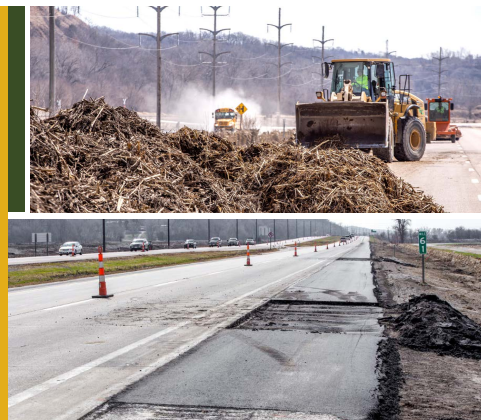
Interstate 29
I-680 to Council Bluffs

- 1.0 Mile Severe Shoulder Damage
- 1.5 Miles Minor Shoulder Damage

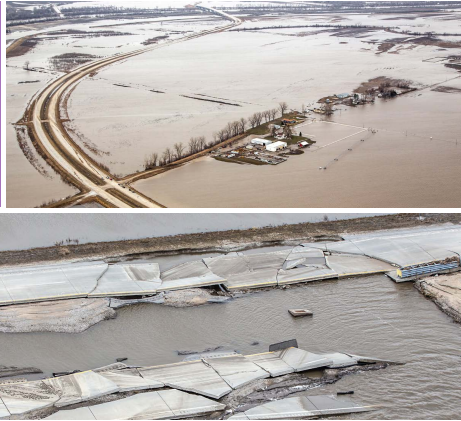
U.S. 34

- 2.0 Miles Severe Roadway Damage
- 5.2 Miles Severe Shoulder Damage
- 0.3 Mile Minor Shoulder Damage
- 2** 1,000' Levee Breach, multiple contractors

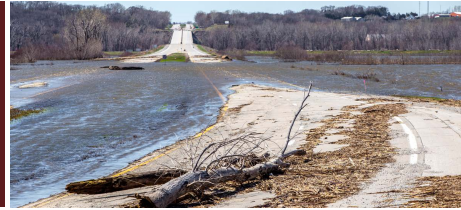
Iowa 2

- 0.1 Mile Severe Shoulder Damage
- 1.0 Mile Minor Shoulder Damage
- Fast-tracked solution to prepare driving surface

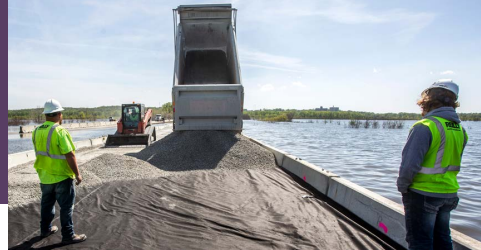
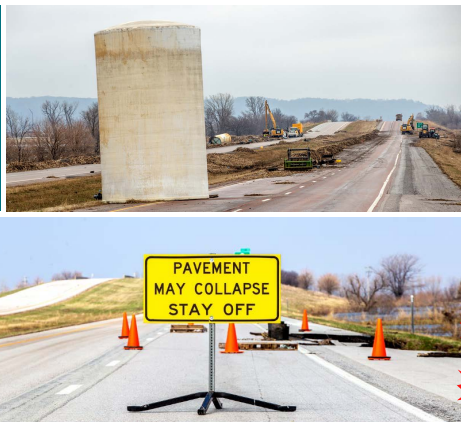
Interstate 29 U.S. 34 to Missouri

- 4.3 Miles Severe Roadway Damage
- 7.0 Miles Severe Shoulder Damage
- 2.4 Miles Minor Shoulder Damage
- 3** Severe damage north of Percival
- 4** Structural damage to Bridges at MM1.4 & MM 8.5

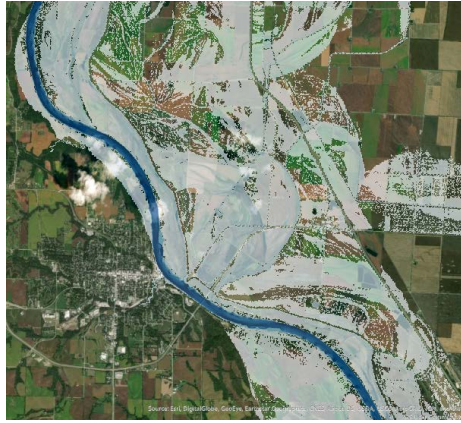
I-29 Corridor 2D Hydraulic Model

Flooding near Nebraska City, March 31, 2019

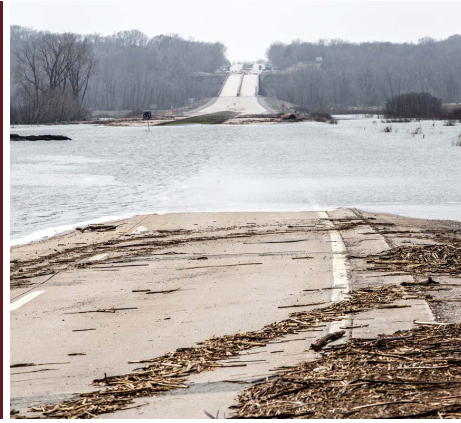
Iowa 2 Overflow Structure

Conceptual Plan and Profile
